RE: Community Improvement Trust appropriations

**FROM:** Qiang Shen, PE; Marselo Marulanda  
Weston & Sampson

**DATE:** May 20, 2026

**SUBJECT:** Freeman Street Fire Station – Revere, MA  
Structural Evaluation of Existing Apparatus Floor Slab

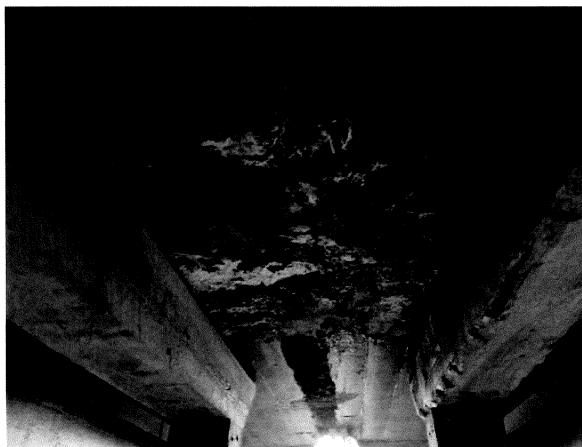
- The concrete floor slab exhibits visible cracking throughout, with noticeable sagging/deflection in multiple areas.
- Surface deterioration is present on the top side of the slab, including scaling and erosion. The deterioration appears consistent with long-term exposure to de-icing salts.
- The underside of the slab shows areas of concrete spalling. In some locations, reinforcing steel may be exposed or at risk of exposure.
- The slab is currently shored with temporary wood columns and beams.
- The bay is used to store a fire engine with an approximate weight of 43,000 lbs.

- The combination of cracking, sagging, surface erosion, and underside spalling in the left bay indicates potential reduced structural capacity.
- Deterioration consistent with chloride-induced reinforcement corrosion is suspected.
- The presence of temporary wood shoring suggests that previous structural concerns have been identified.
- The current imposed load from the 43,000 lb fire engine may exceed the reduced capacity of the deteriorated slab.

*Concrete Spalling and Shoring (Left Bay)*

- Consider restricting heavy vehicle parking in the left bay until structural adequacy is confirmed.
- Evaluate the safety and adequacy of the existing temporary shoring.

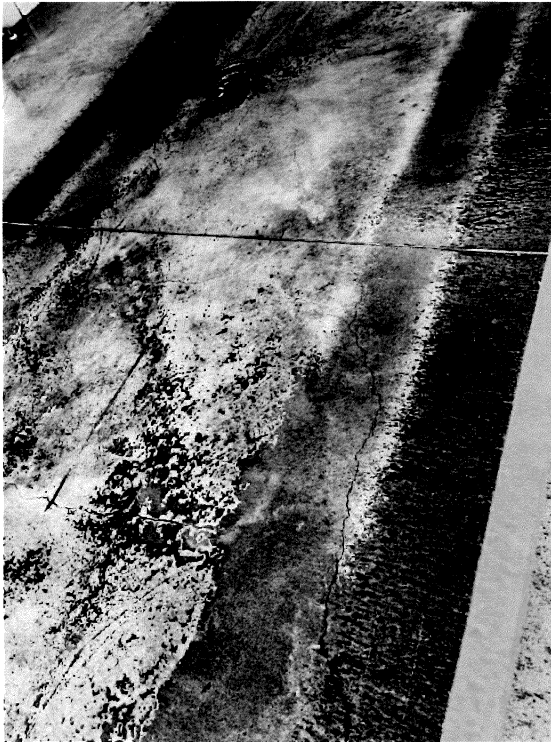
Floor Corrosion and Cracking (Left Bay)

- Remove full depth of left bay slab and replace it with a new concrete slab. Add new steel beams and columns between the existing concrete beams to shorten the new concrete slab spans.

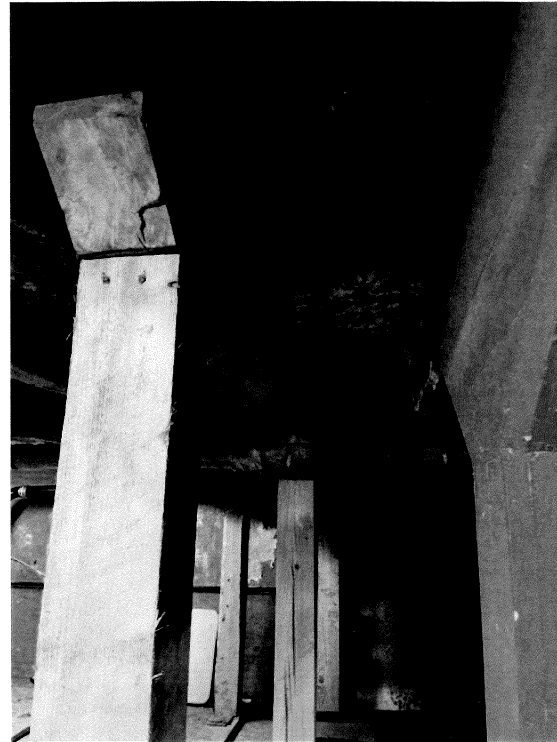
Floor Shoring (Left Bay)

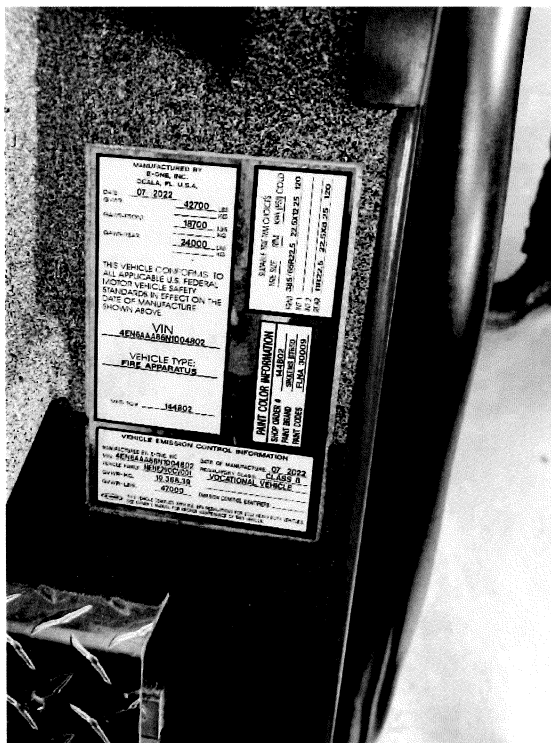
Fire Engine Specified Weight and Wheel Loads (Left Bay)

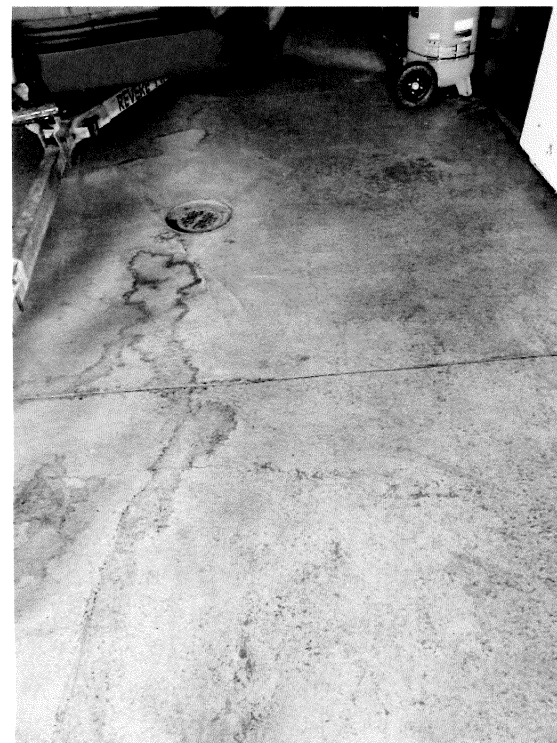
- The concrete slab in the right bay appears to be in comparatively better condition.
- Minor surface wear is present but no significant sagging or widespread spalling was observed.
- This bay is used for light vehicles only.

Floor Condition (Right Bay)

The right bay slab is currently in serviceable condition but should be periodically monitored for future deterioration.

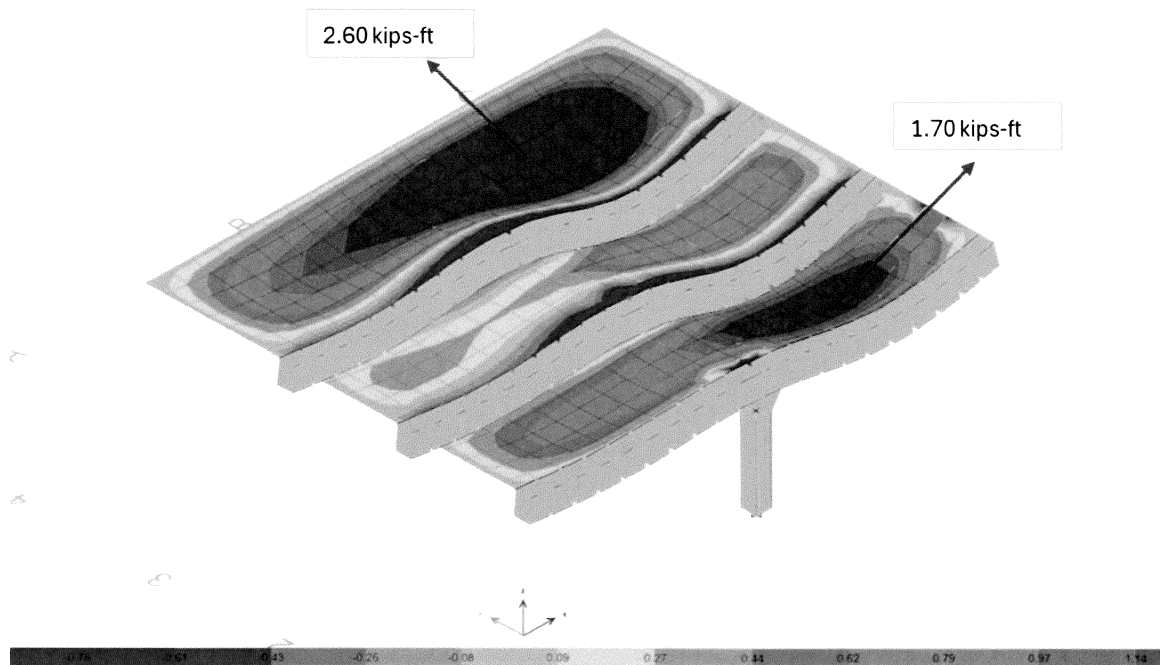
*Slab Flexural Results*

ETABS Concrete Structure analysis software was used in this analysis. The following charts show the results of the analysis which indicate severe overstress in the slab.

Stress ratio: 218% overstressed.

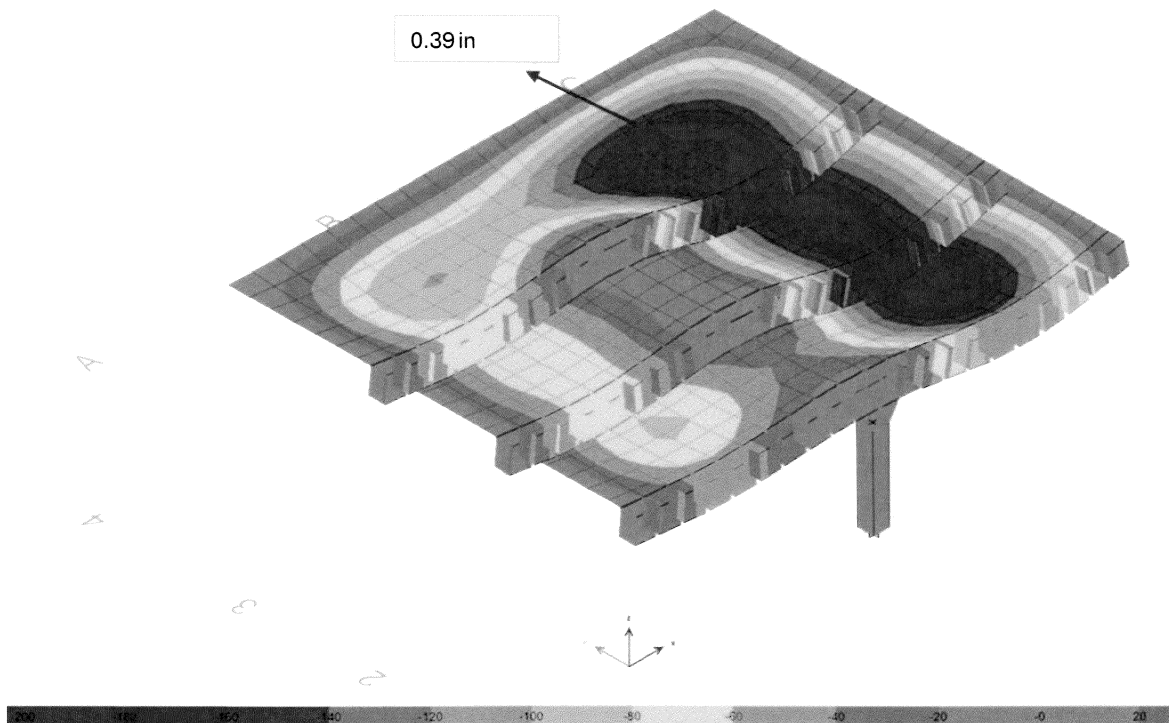
Slab Deflection Results

Live load deflection ratio: 47%

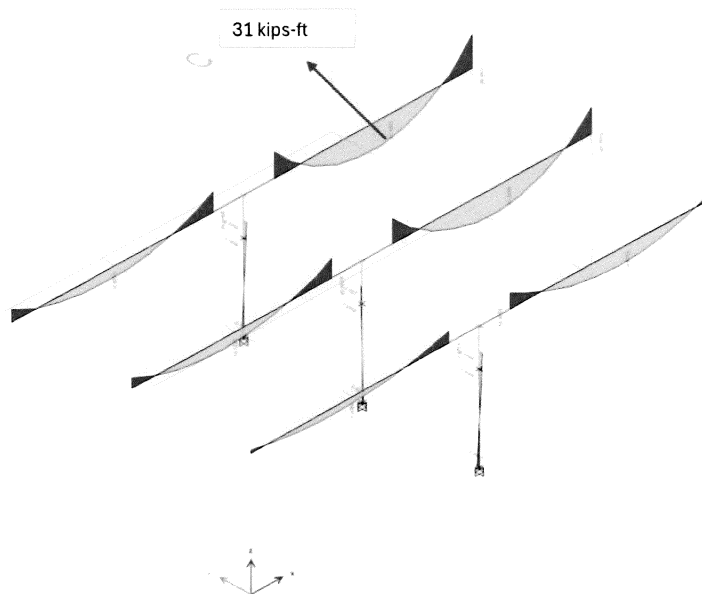
*Floor Beam Flexural Results*

Flexural stress ratio: 92%.

Shear stress ratio: 117%, overstressed.
